CASE STUDY

WATERLOO INTERNATIONAL TERMINAL - BEARING REFURBISHMENT & REPLACEMENT

Job Brief

Scope: Design and installation of temporary works and bridge jacking. Bearing removal and refurbishment. Design, supply and installation of 10 no. Pot and 3 no. F-Type bearings. Removal of surplus bearings. Supply and installation of ES seal expansion joints.

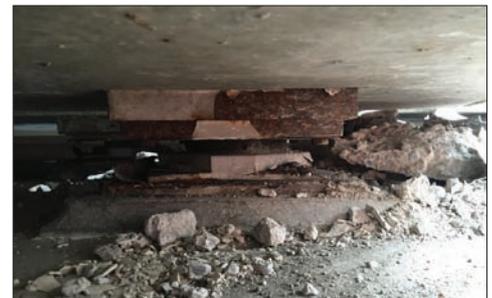
Existing bearing showing excessive corrosion as a result of water leakage from the deck

Ekspan were contracted by Skanska to carry out all bearing and joint removal, installation and associated refurbishment works. A full survey, with photographs, was undertaken of each bearing on the D and E bridge decks of Waterloo International Terminal. All findings associated with identification, overall dimensions, bearing condition, bearing plinths, soffit and jacking points were recorded. This survey together with results from a prior inspection verified extensive surface corrosion caused by the ingress of water through the decks' movement joints. Damage to the rubber around the bearings and peeling of paint work was also visible.

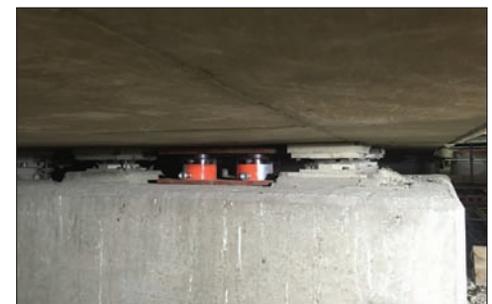
Bearing shelf - localised jacking prior to bearing removal

Ekspan's programme of works were carried out sequentially following installation of falsework and hydro demolition of the concrete deck edge slabs and bearing shelf at specified locations. The jacking system and temporary works designed and installed by Ekspan, allowed accurate monitoring of the bridge deck throughout the works. The final phase of works following bearing installation included installation of the ES seal expansion joints.

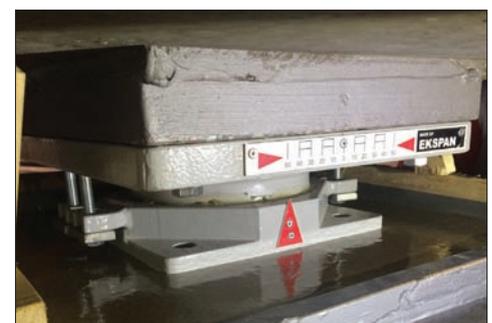
Free bearing installed
