CASE STUDY

TOWER BRIDGE - LONDON HIGH LEVEL GLASS WALKWAY INSTALLATION

Job Brief

Supplied: Fabrication and installation of 2 no new glass floors on Tower Bridge's West and East High Level Walkways.

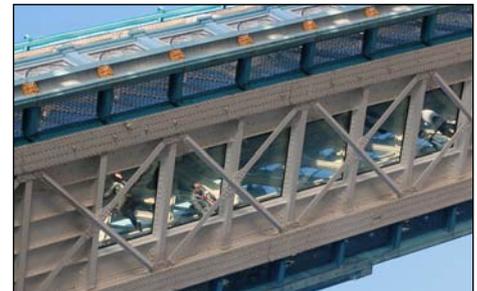
West Walkway underside - roadside view looking up at the fitted glass panels

Each walkway is fitted with 6 reinforced glass panels (each weighing 530kg) supported within a fabricated carbon steel frame weighing approximately 1000kg. The glass panels combined measure a length of 11m by 1.8m width per walkway.

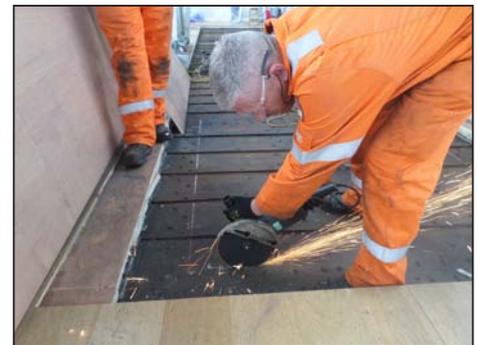
Cutting the existing steel floor

Works commenced with an initial survey and assessment of the current walkway floors to finalise the design and manufacture of the steel supporting structural frames to hold the glass panels. An underslung gantry was then installed to act as a working platform to undertake the works from. The existing oak flooring and substructure local to the final glass panel positions were carefully removed in various stages - starting with removal of 20mm thick oak boards, 18mm plywood boards, 45mm thick PIR insulation boards and rubber matting. The screed layers, after marking the frame locations, were broken and removed to reveal the original steel flooring. The steel flooring was marked to size for cutting and removing in sections before new steel framework and glass panels could be installed. The original surrounding oak flooring was then reinstated to complete the installation.

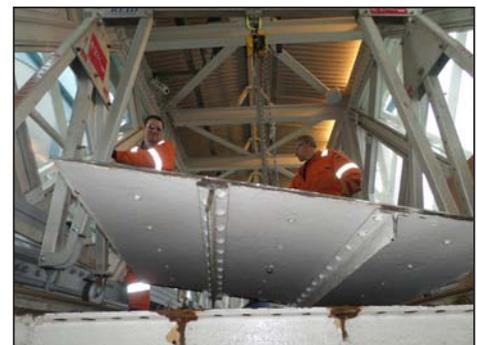
Steel floor section lifted after cutting
